# Manhole Inspection Summary

Manhole # S25GG1035MH

Insp Date: **1/18/07 11:38 AM**

**Location** Address: **1035 40TH ST**

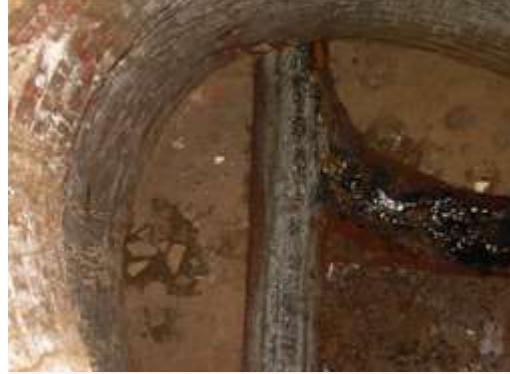
Top View

Evidence of surcharge - Bench debris.  
Channel debris.

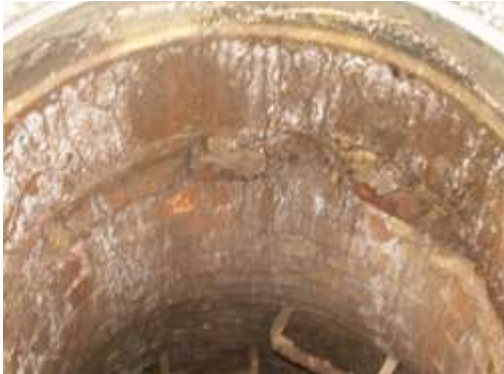
Defect

☒ **Leaks**

Condition: ☐ Sound ☐ Cracked ☐ Root Intrusion ☒ **Loose Brick** ☒ **Deteriorated**

Infiltration: ☐ None ☒ **Joint** ☐ Cracks ☒ **Mortar** ☐ Roots ☐ Wall

Frame leaks. Adjustment deterioration,  
loose brick and infiltration.

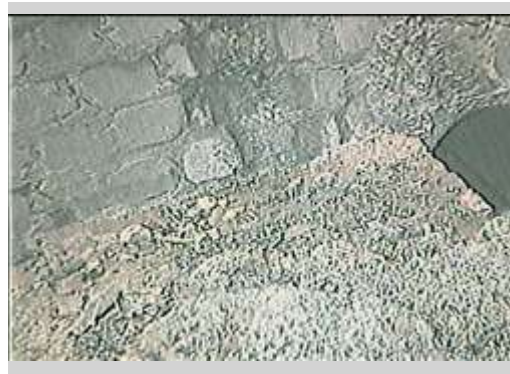
Defect

Condition: ☐ Sound ☐ Cracked ☐ Root Intrusion ☐ Loose Brick ☒ **Deteriorated**

Infiltration: ☐ None ☐ Joint ☐ Cracks ☒ **Mortar** ☐ Roots ☒ **Wall**

Barrel deterioration and infiltration. Bench  
debris.

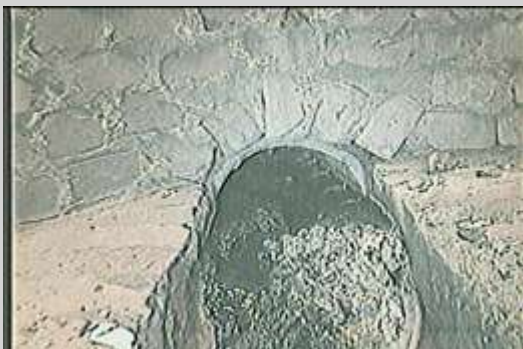
### 8 in. Circular Gravity Sewer Pipe In @ 3 O'Clock

Deposits: ☐ None ☒ Mud ☒ Sludge ☒ Debris ☐ Grease

Silt Depth: **5** (in.) Deposits Extent: **Heavy**
